780 HANDHELD TEST INSTRUMENT CASE STUDY

Diagnosing HDMI Interoperability Problems in a Retail Store

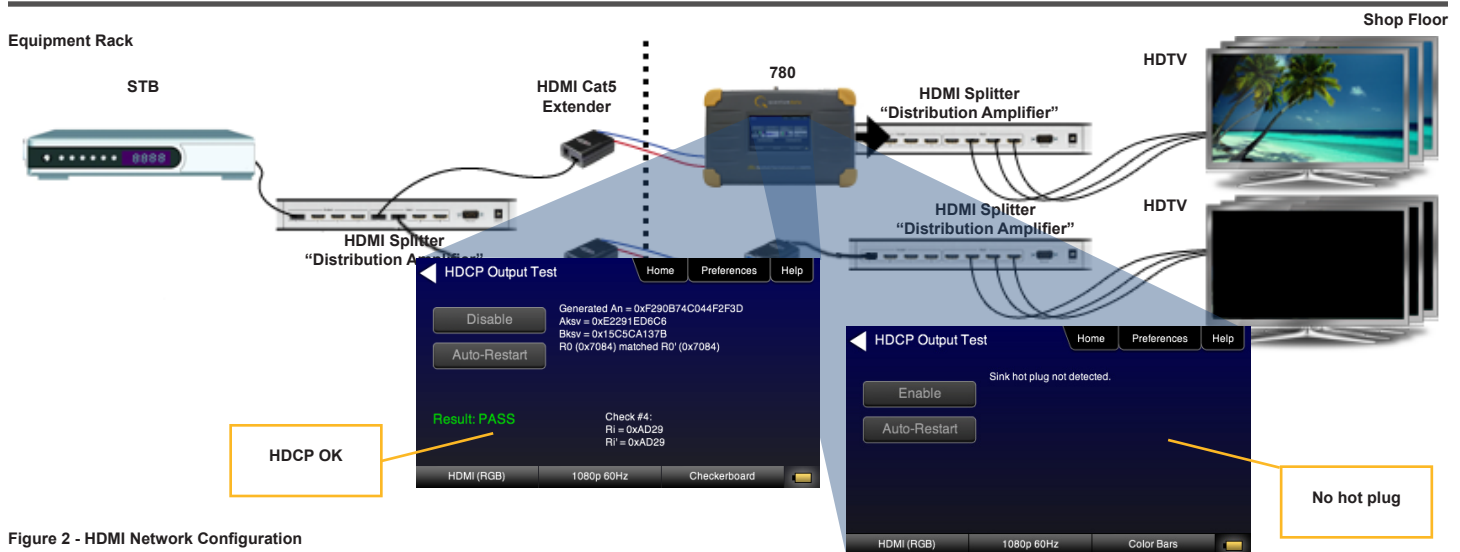
Figure 2 - HDMI Network Configuration

Results (Test #1): The results were mixed with some of the paths showing failure and others showing that the signal path was good. In some cases the results were dependent on the resolution. When testing with 480p60, an image was rendered through the signal path. When 1080i was used, often the problem of intermittent flashing exhibited itself. But the results did not appear to depend on HDCP. In the cases of intermittent failure, it was determined that the cable runs were too long to pass the higher resolutions. These cables were replaced.

In signal paths where there was no video at all, it was determined that either some of the ports on the splitter were bad or the cables were bad. These problems were related to improper hot plug. When tested at the input side of the distribution amp, the tests often indicated too low of a hot plug signal at the source; in this case the 780 was acting as a source. The ports on the splitter that showed a failure were not used.

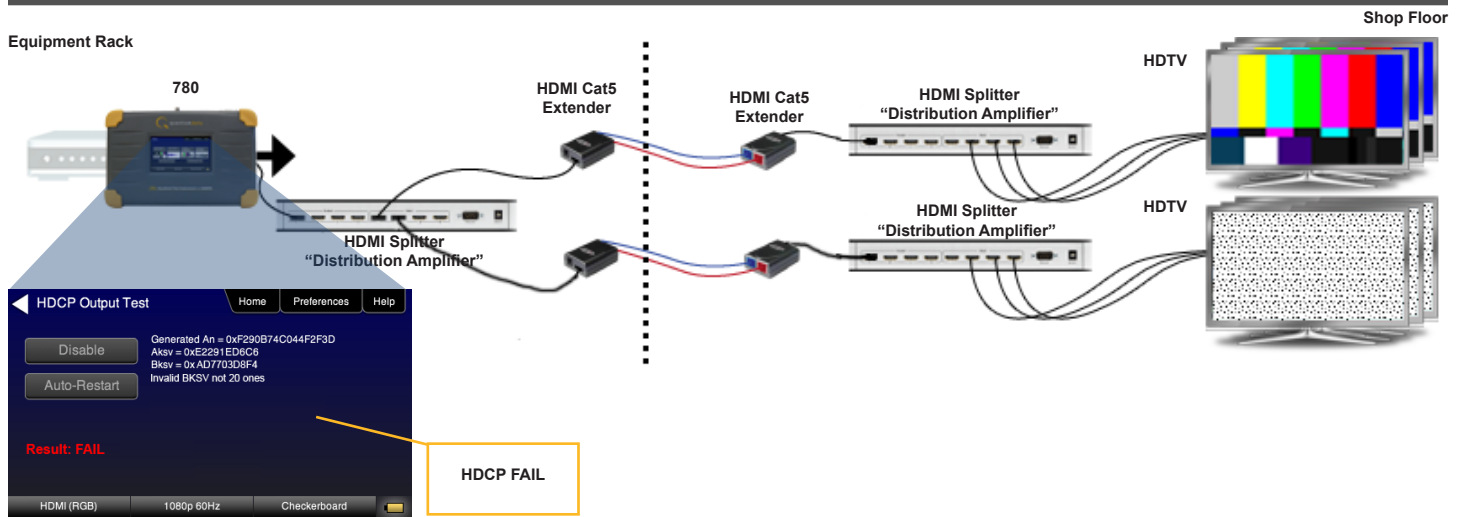
Figure 3 - HDMI Network Configuration

Results (Test #2): The results were again mixed with some of the paths showing failure and others showing that the signal path was good. The results were not dependent on the resolution. However, the results did correlate with HDCP. Therefore an HDCP authentication problem was a possible cause and specifically errors on the DDC bus used to carry the HDCP transactions were suspected. Additional testing was required to determine the root cause.

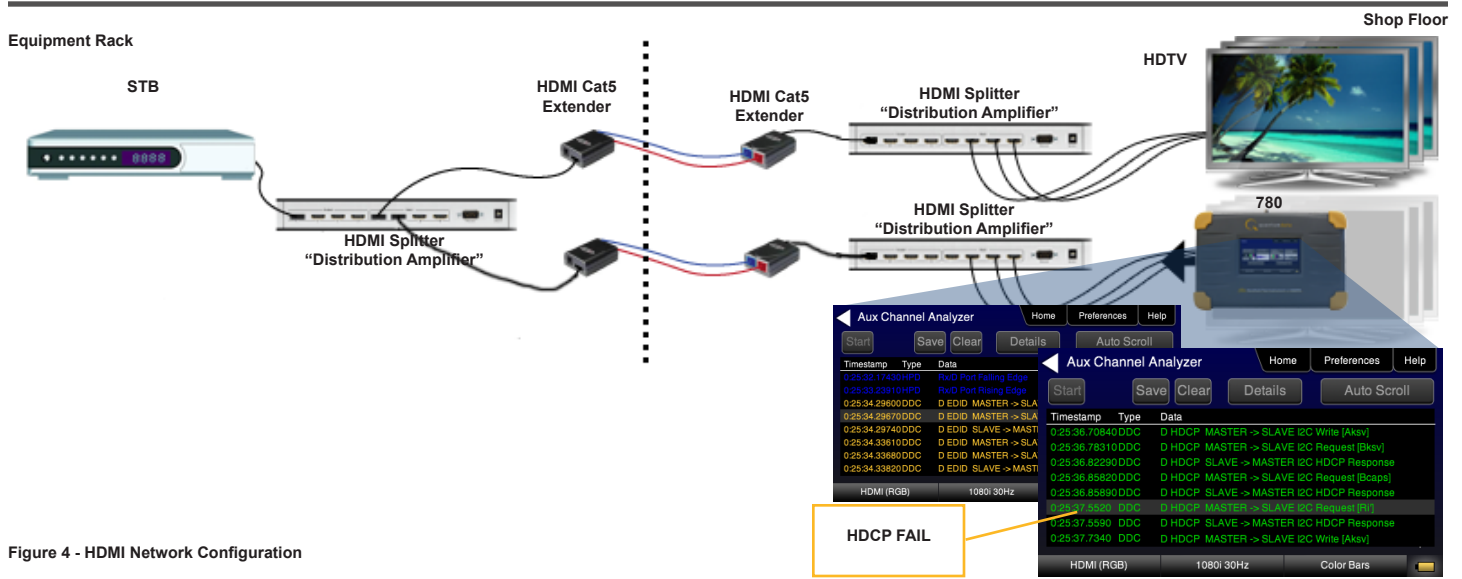
Figure 4 - HDMI Network Configuration

Results (Test #3): The results showed that the DDC bus was dropping out and losing packets of data on the HDCP transactions. The HDMI over CAT5 extenders were rated to 1080i at 40m, the CAT5 run was measured with a TDR meter at 39 meters. The extenders units were replaced with new units rated to 100m and the test was rerun. It was then seen that the system was not losing any HDCP transactions. The root cause of the problem was related to HDCP transaction failures due to errors on the DDC bus.
