780 HANDHELD TEST INSTRUMENT CASE STUDY

Diagnosing HDMI Interoperability Problems in a Retail Store

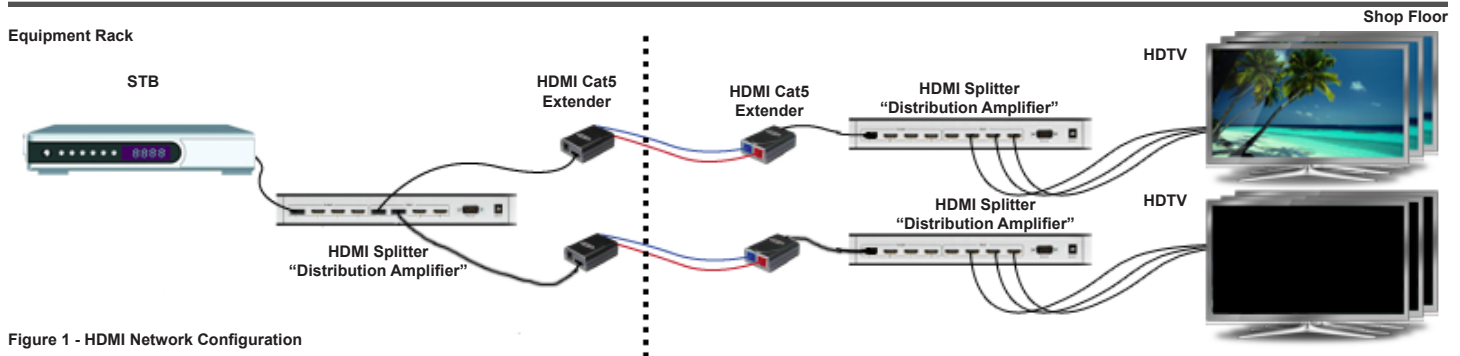
Figure 1 - HDMI Network Configuration

Network Setup: There was a satellite set top box (STB) connected to multiple displays on the shop floor of a business. The STB was connected to the displays over HDMI 2x CAT5 extenders with distribution amplifiers (splitters). The network setup is depicted in the illustration below.

Symptom: Several HDTVs were not working at all. Some were flashing intermittently. Intermittent flashing is indicative of a physical layer problem related to dielectric loss. If the flashing were periodic, this would indicate that the problem was related to HDCP.
