980/M41h/M41d/M42d 6.25 Release

Updated: April 23 2021

1. Overview

This document provides information on Release 6.25 of the firmware for the 980B/M41h/M41d/M42d and for the Advanced Test Platform (ATP) GUI Manager (PC based External Manager Software).

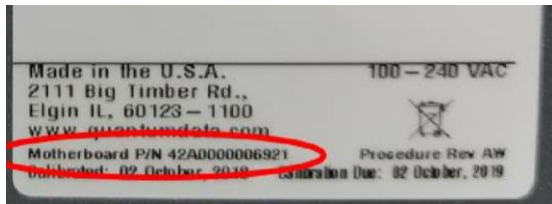
4. On the product label on the back (980B) or bottom (980R) of the instrument, check for Motherboard P/N 42A0000006921 or 42A0000009220:

If the ATP version shows 64 bit, or if the label shows either of the above part numbers, then download the “980-atp-64” firmware. Otherwise, you have a 32-bit system, so download the “980-atp-32” firmware.
